Subject: 2022 Annual Report
Inactive Portion of Former ARCO Chemical Company
East Landfill Area, Monaca, PA
CEC Project 142-329

2022 ANNUAL REPORT

LE PETOMANE EAST LANDFILL AREA
MONACA, PA

September 2021 Inspection and Maintenance Survey
Le Petomane East Landfill Area
CEC Project 142-329

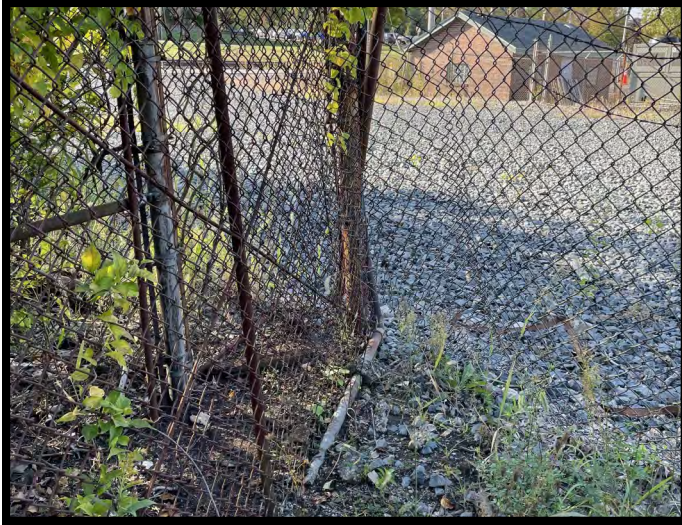
Damaged Fence at Main Gate

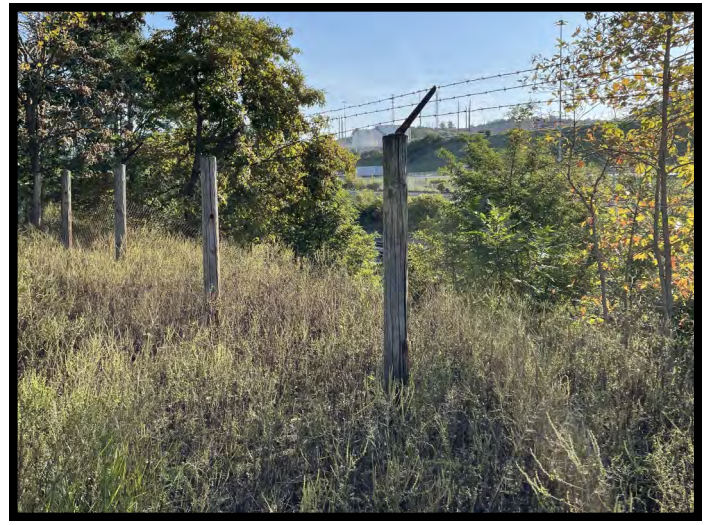
Damaged Fence, Near Train Tracks

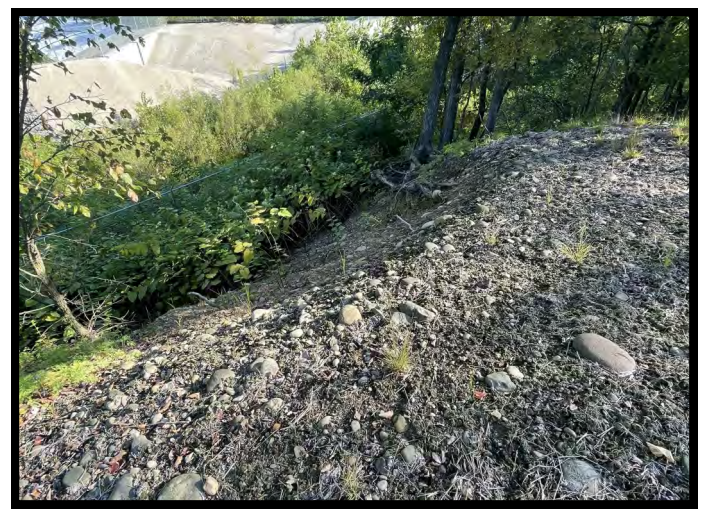
- Minor erosion along Poorhouse Run, near former well location EL-7. Seen in all site visits.
- Ponding water observed in the Latex and Phosphate areas 4Q21 and 1Q22. Not observed in 3Q21 or 2Q22.

The final cover remains in good condition, with the cover and vegetation fully established. The only notable issue is minor erosion of the bank along the Poorhouse Run, near former monitoring well location EL-7. A similar erosion pattern has been noted in this area during since 2018, and the extent of erosion has not expanded since that time and appears stable. Lastly, the perimeter fence remains damaged, jeopardizing site security.

Minor Erosion Near EL-7

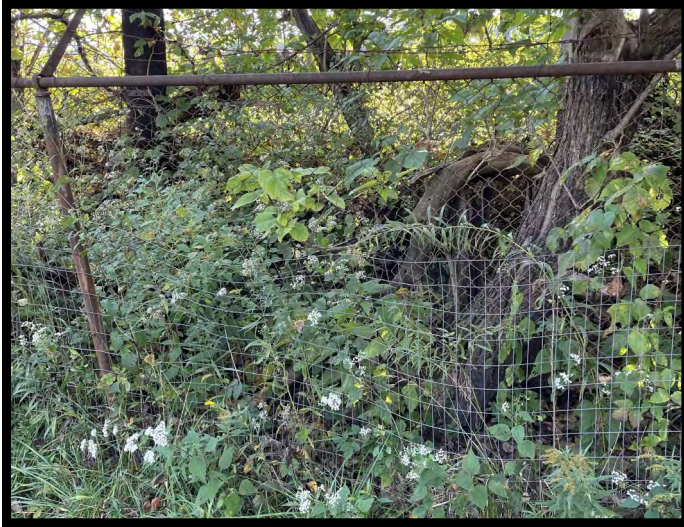
Damaged Fence Along Tracks

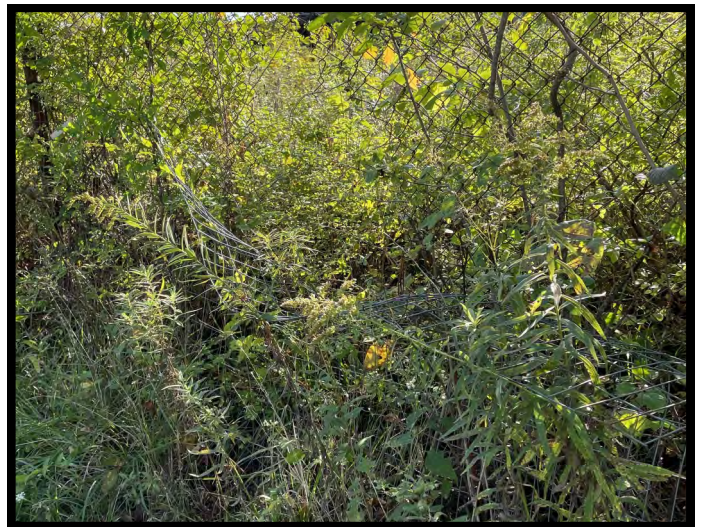
Damaged Fence Along Tracks

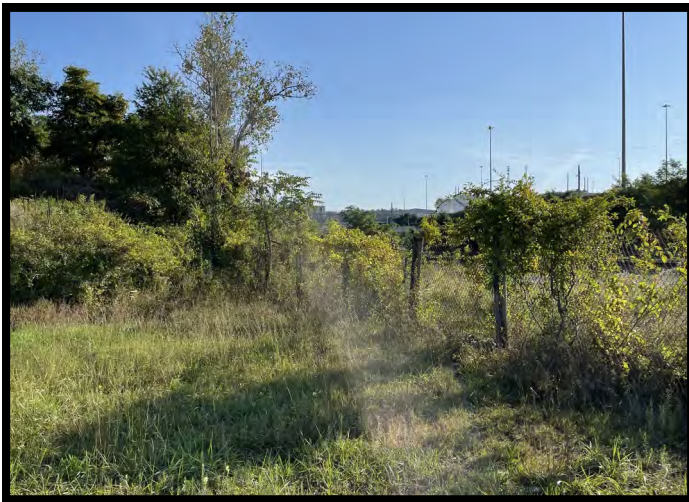
Loose Fence by Railroad

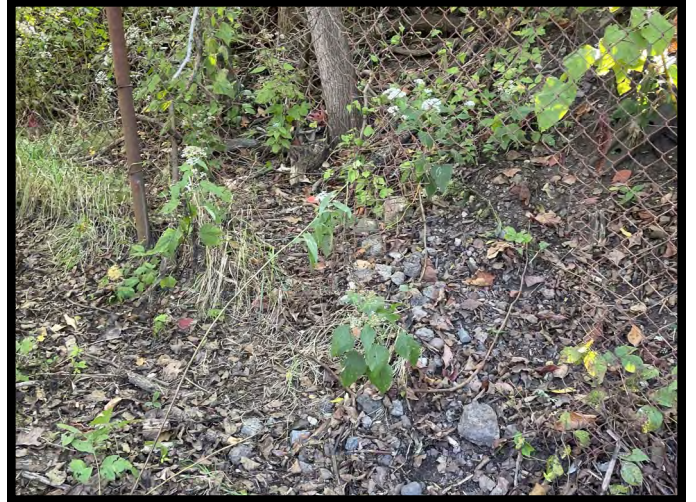
Damaged Fence

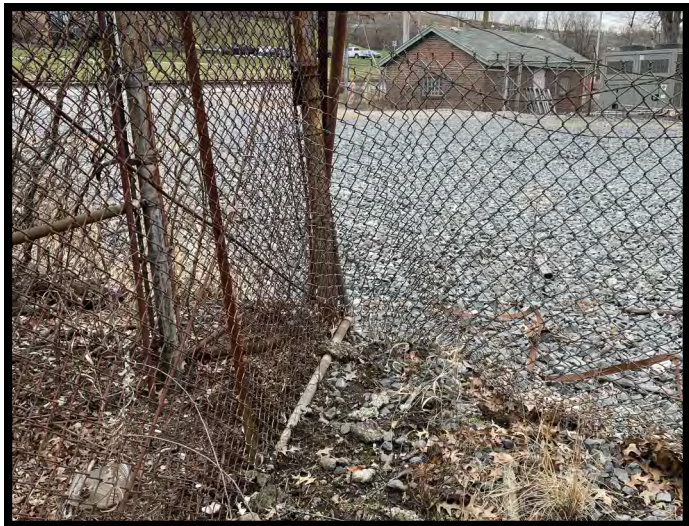
Damaged Fence at Main Gate

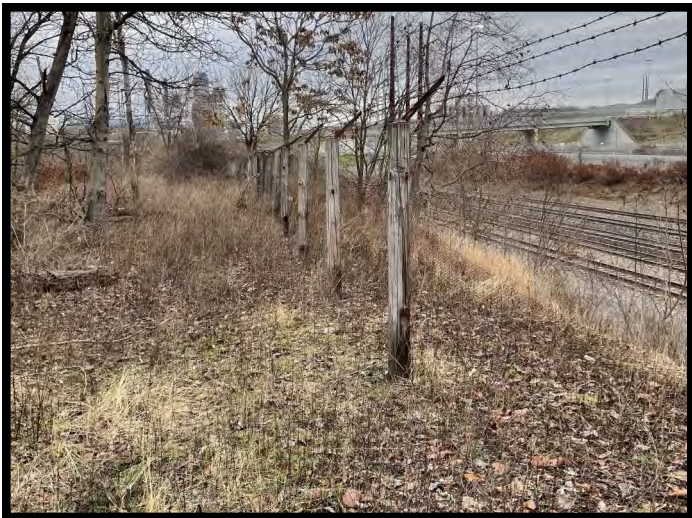
Damaged Fence, Near Train Tracks

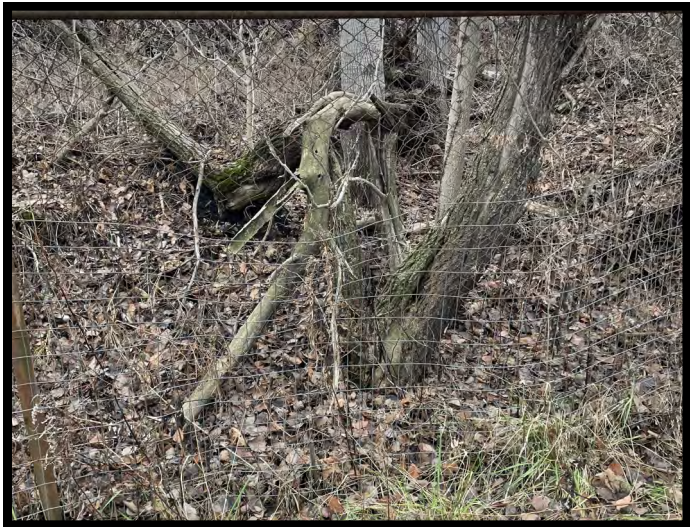
Damaged Fence Along Tracks

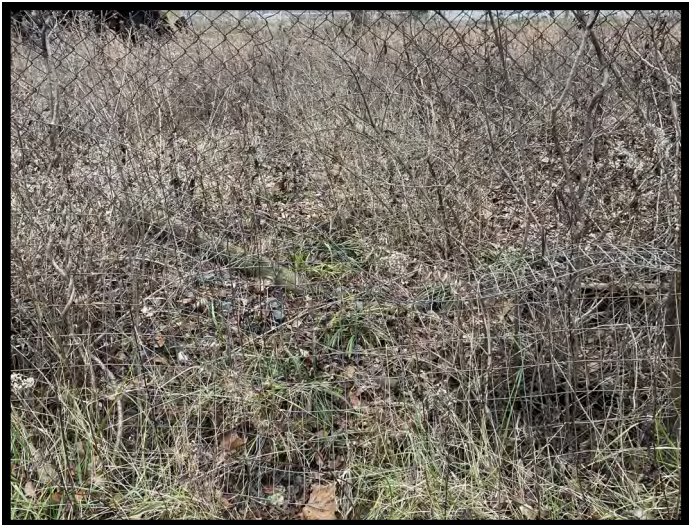
Damaged Fence Along Tracks

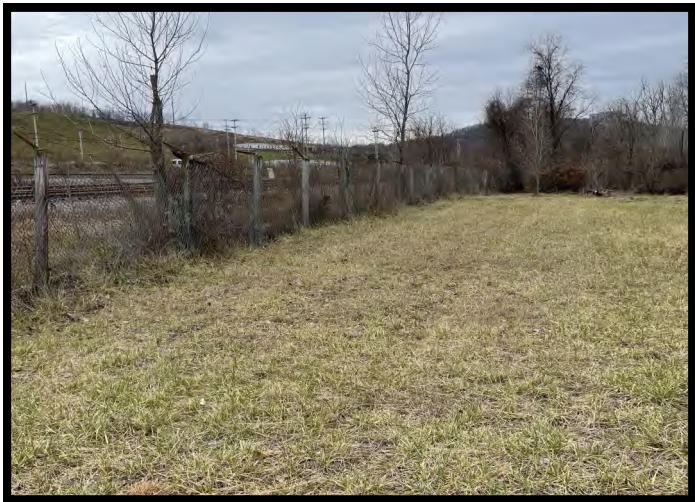
Loose Fence by Railroad

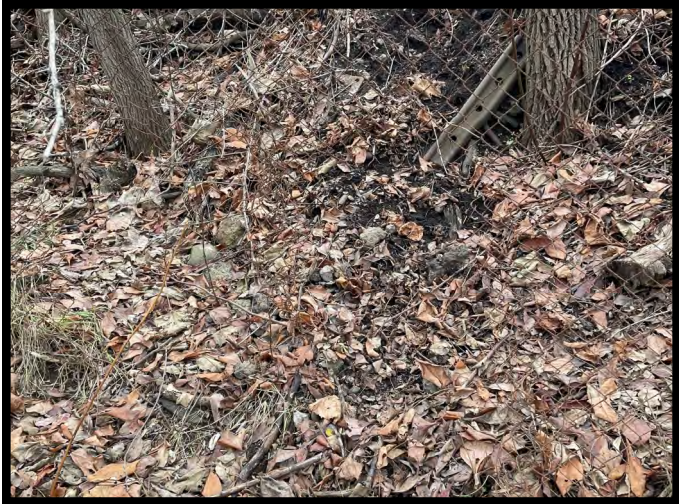
Damaged Fence

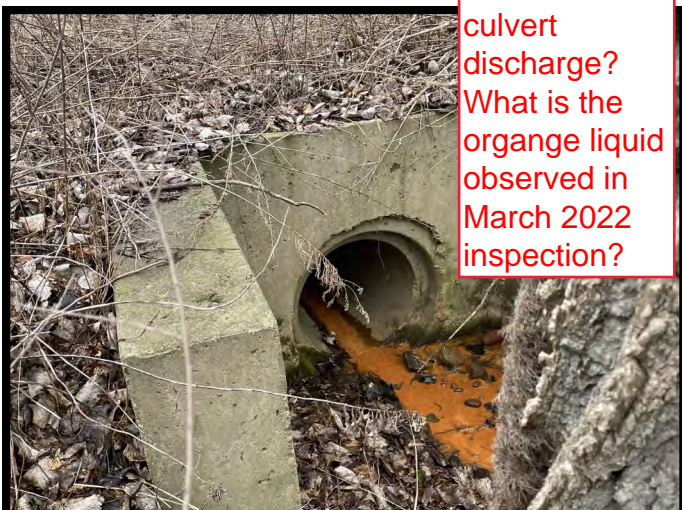
Culvert EL-1

Where does
culvert
discharge?
What is the
orange liquid
observed in
March 2022
inspection?

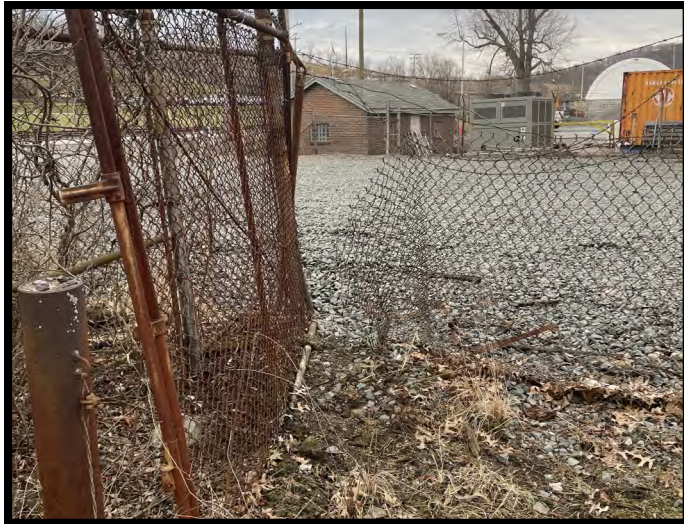
Damaged Fence at Main Gate

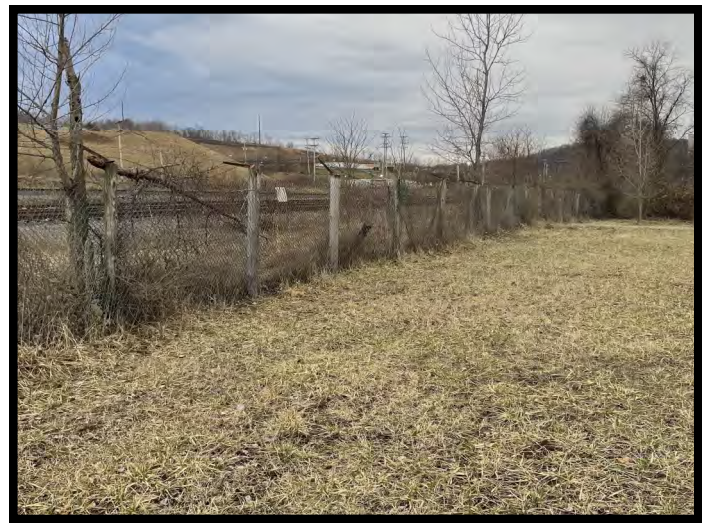
Damaged Fence, Near Train Tracks

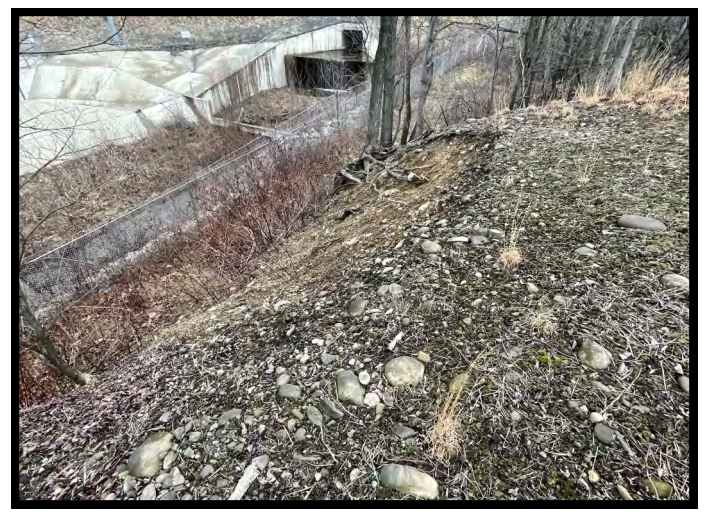
Minor Erosion Near EL-7

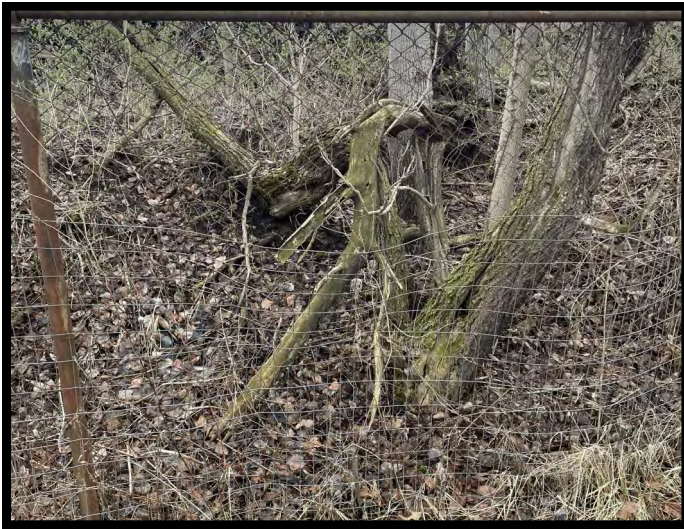
Damaged Fence Along Tracks

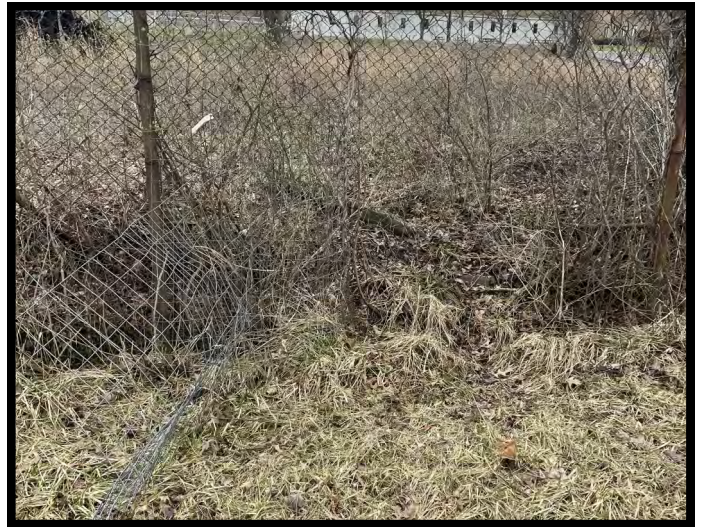
Damaged Fence Along Tracks

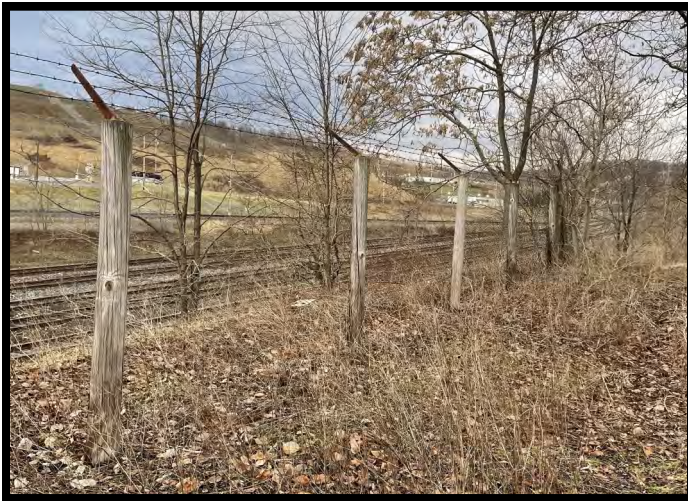
Loose Fence by Railroad

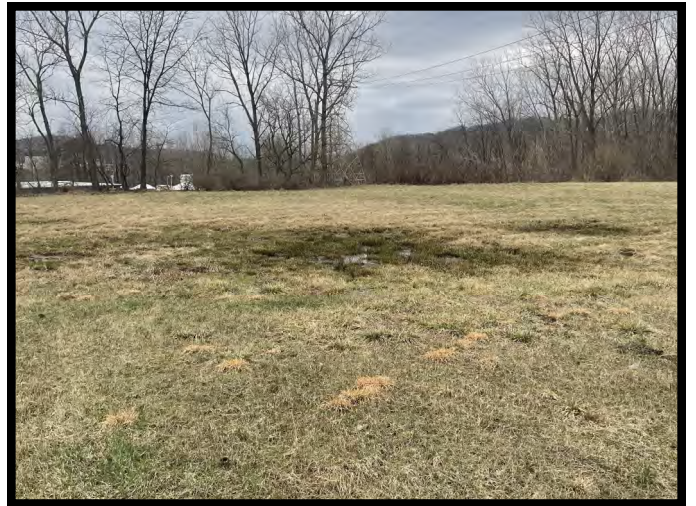
Pooled Water Phosphate and Latex Area

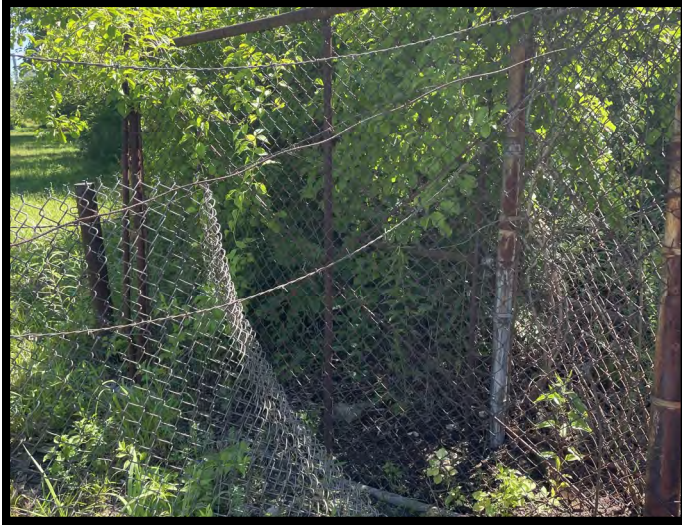
Damaged Fence at Main Gate

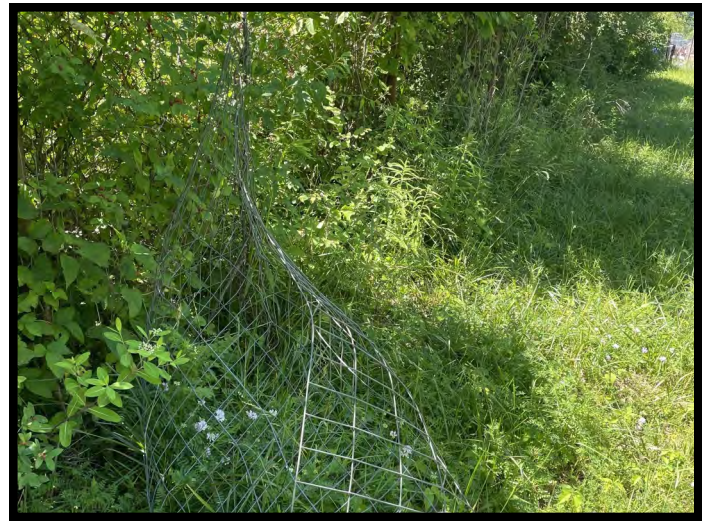
Damaged Fence, Near Train Tracks

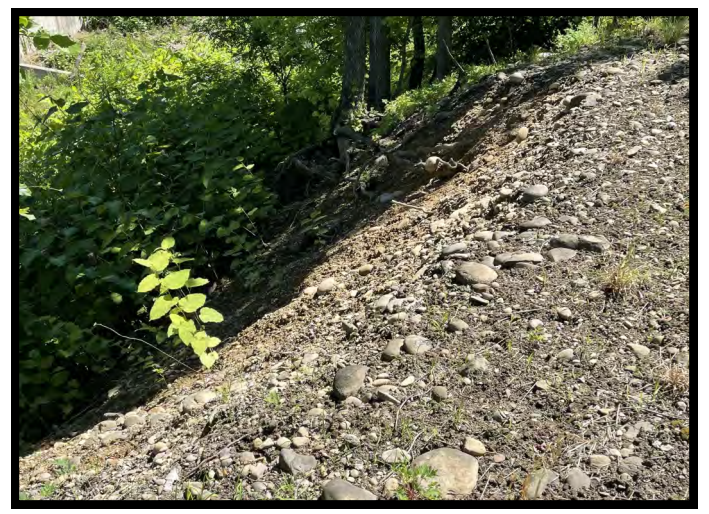
Minor Erosion Near EL-7

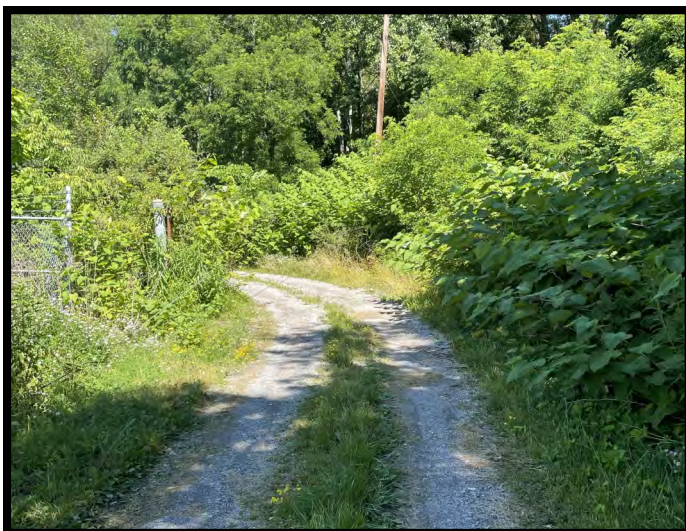
Open Gate on Access Road

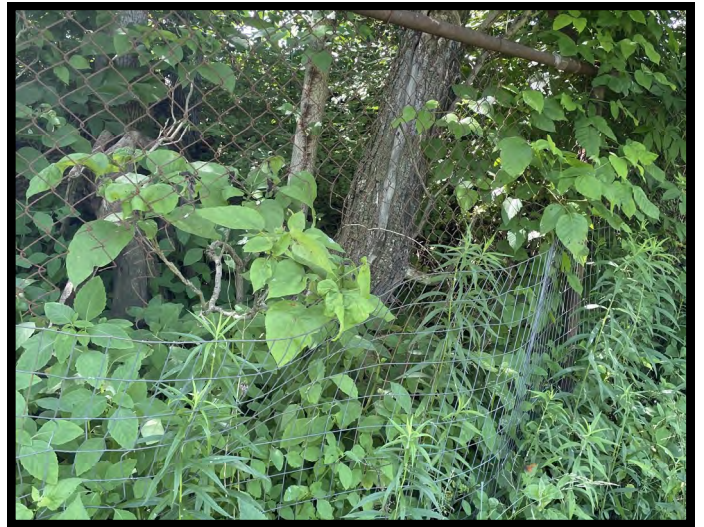
Damaged Fence Along Tracks

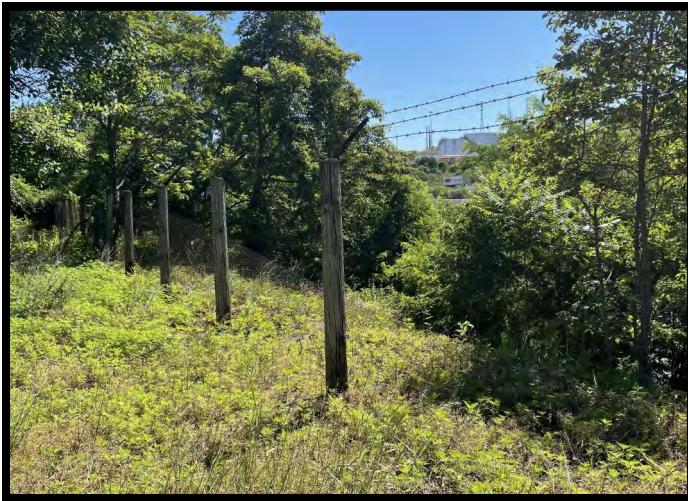
Loose Fence by Railroad
